**PRELIMINARY ASSESSMENT/
VISUAL SITE INSPECTION**

**1330 SOUTH KILBOURN AVENUE FACILITY
FORMERLY THE VALSPAR CORPORATION - PAINT
CHICAGO, ILLINOIS**

FINAL REPORT

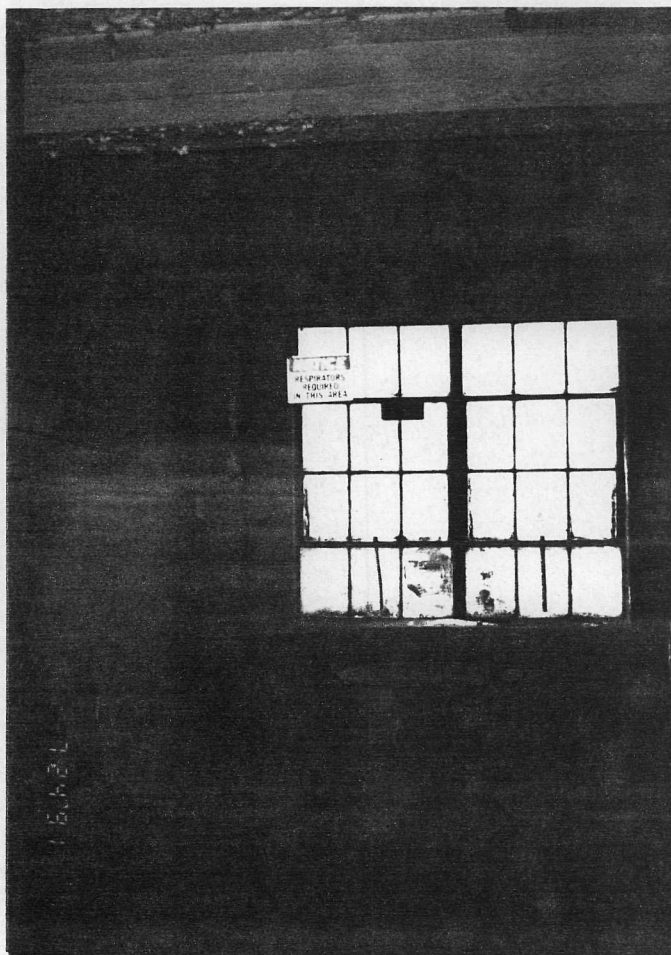
Photograph No. 102

The fifth floor of Building 8 was empty except for one vat about 3 feet in diameter and several feet deep located in its southwest corner (see photographs 102 and 103). The vat contained chairs and was not discussed in information provided to PRC after the VSI (IT, 1990b). The building contained scattered debris, but the floor was relatively clean in comparison to the remainder of the buildings on the fifth floor. Graffiti was painted on the walls of this building.

This picture shows an open-topped tank located in the southwest corner of the fifth floor in Building 8. Note the sign in the center of the picture. This may indicate that this area was used to measure out powders or solvents for paint batches. The tank was filled with miscellaneous solid debris such as wood.

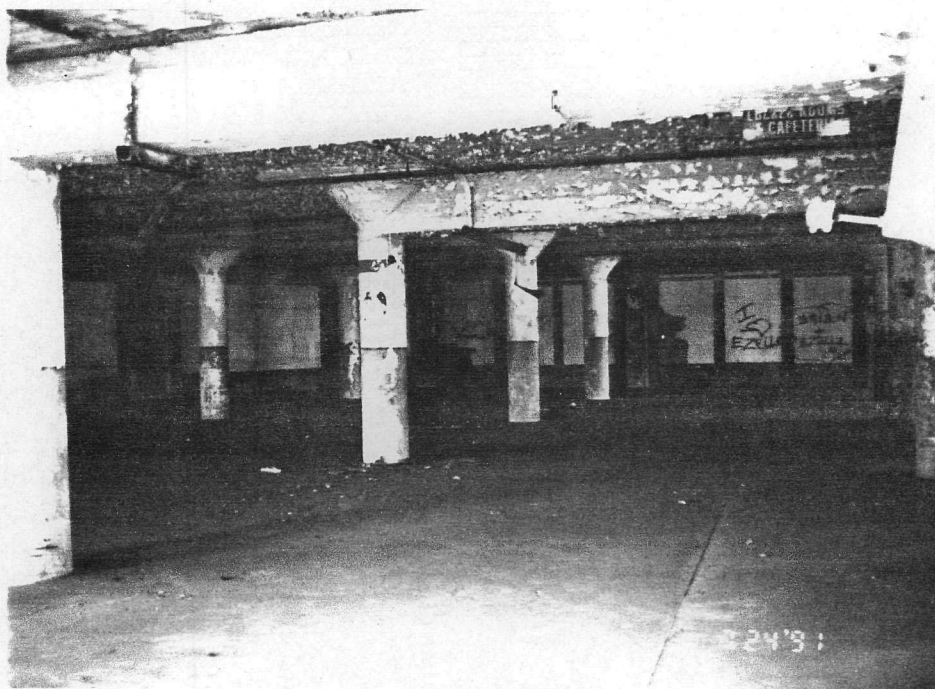
Photograph No. 103

Description: This picture shows a general overview of the fifth floor of Building 8. Note the peeling paint and the graffiti on the wall in the background. Based on the clean appearance of this room, PRC believes that it was used for raw material storage.

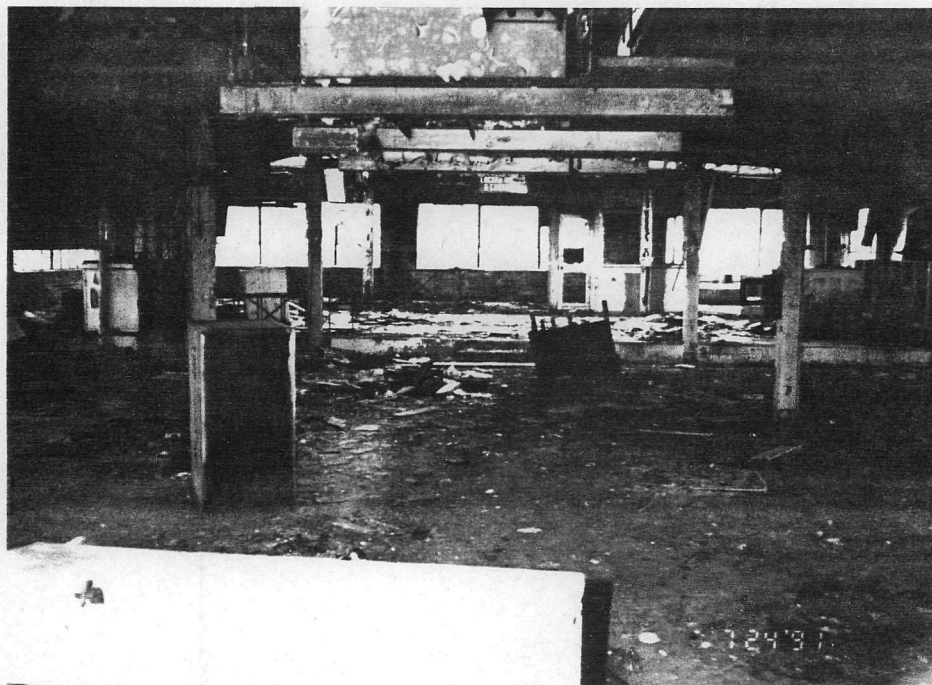
Photograph No. 104

The sixth floor of Building 12 was damaged by a fire (see photograph 104). PRC found no discussion of a fire in this building in any documents reviewed during the PA. The sixth floor appears to have contained an office space. PRC observed the remains of filing cabinets and desks. One empty drum was found in this room. Stairs lead from the sixth floor of Building 12 to a penthouse above the building. The penthouse appears to have been a residence, and it was equipped with a kitchen, several rooms, and a restroom. During the VSI, Goodwill speculated that the penthouse was used by Valspar executives visiting Chicago for meetings.

Description: This picture shows the eastern part of Building 12's sixth floor. A great deal of fire damage was visible in this room, especially in the northern part. Based on the number of file cabinets in this area, PRC believes that it was used for office space.

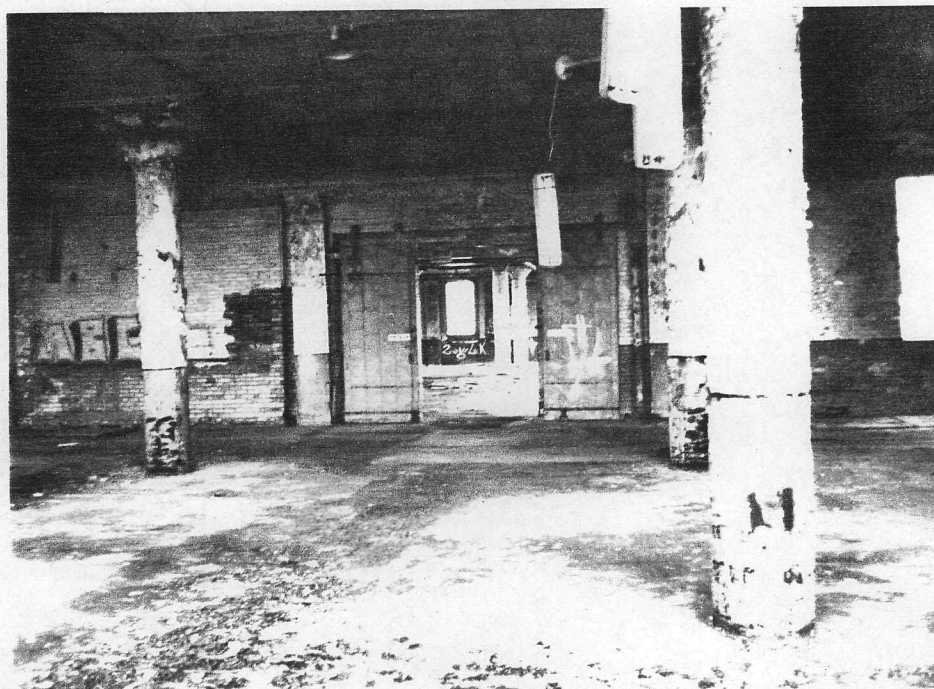
Photograph No. 107

The sixth floor of Buildings 7 and 8 are empty except for small, stagnant pools of standing liquid containing what appeared to be green algae (see photograph 107). Debris is scattered about the floor of both rooms, including paint chips and piping insulation.

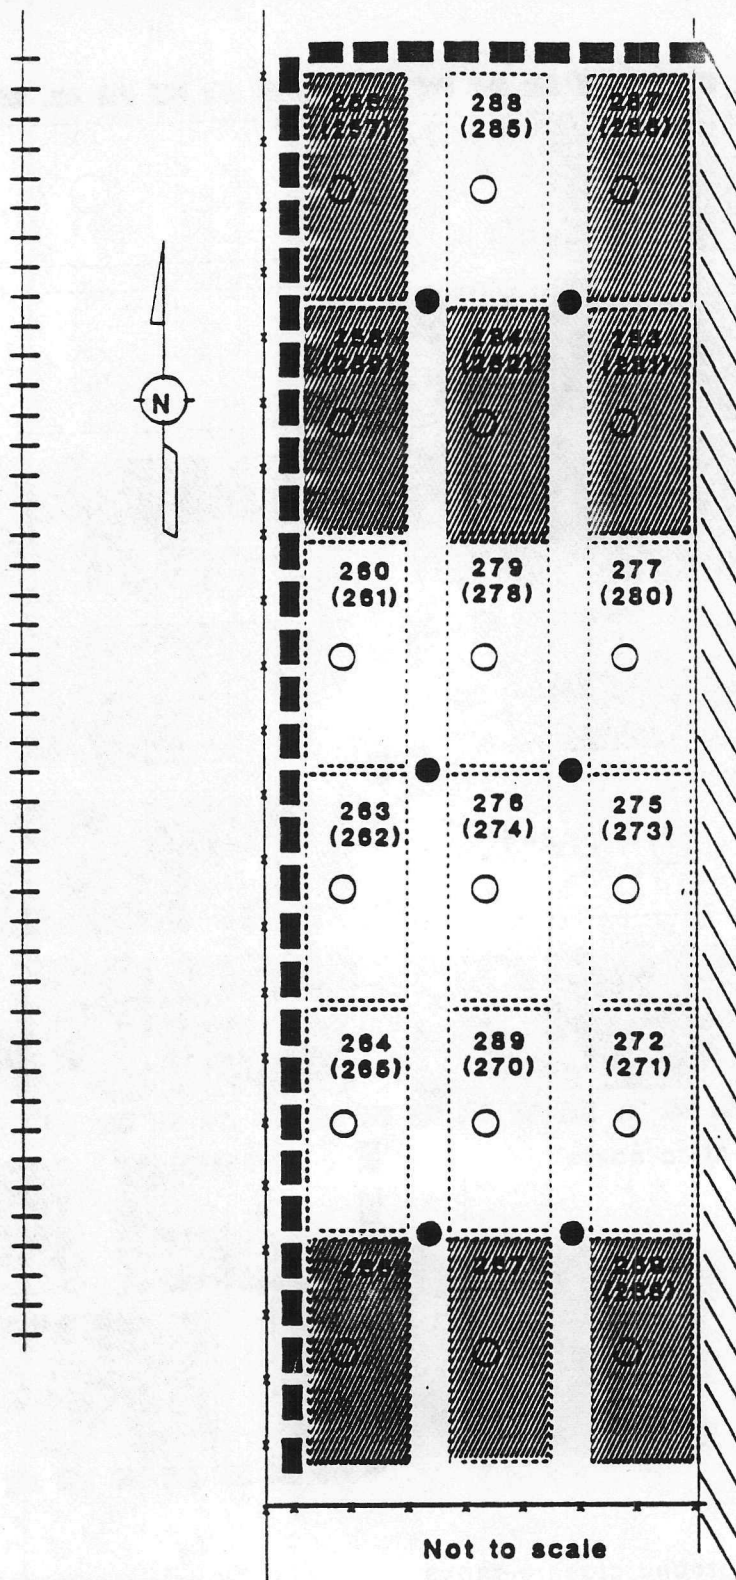
Figure 4
Tank Layout
South Tank Area
prepared for
Kilbourn Ave. Location

- Nine locations in Cooper's Pit (Building 7C). See Figure 2.
- Five locations in the north tank farm. See Figure 3.
- Ten locations in the south tank farm. See Figure 4.

Soil Sampling Locations
